# HIDDEN ARCHITECTURE. RESTORATION OF HISTORIC TIMBER STRUCTURES: THE GREAT ROOF STRUCTURES OF THE CATHEDRAL OF VERCELLI

Clara Bertolini Cestari  
Gianoreste Biglione  
Politecnico di Torino  
Dipartimento di Progettazione  
Architettonica e di Disegno Industriale  
Viale Mattioli 39  
10125 Torino]  
Italy  
[clara.bertolini@polito.it](mailto:clara.bertolini@polito.it)

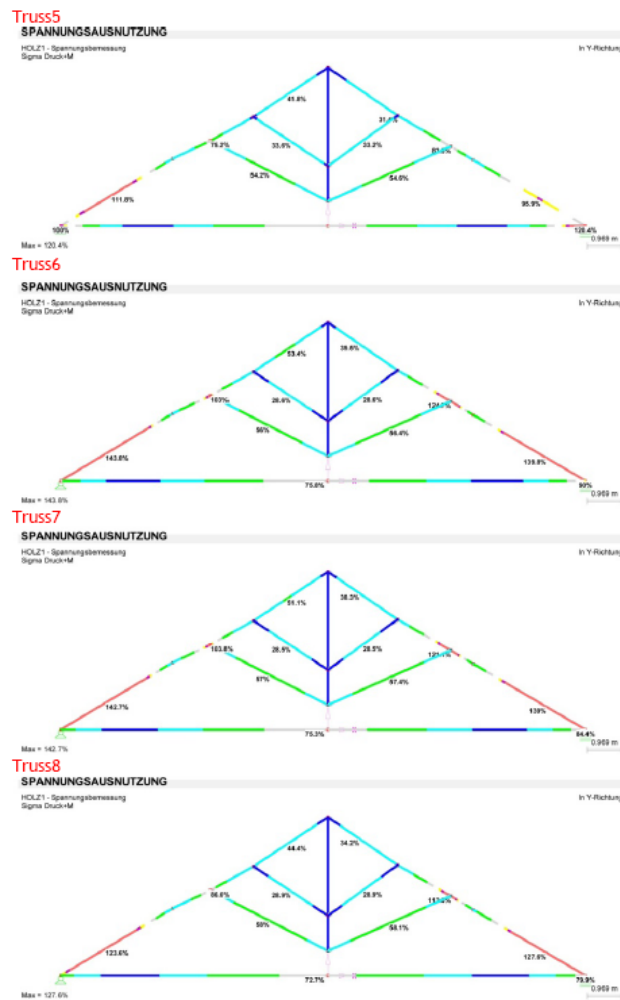
Figure 9: Structural models reporting decays and defects of the components (stress in the lower part of the rafters is generally a too high)

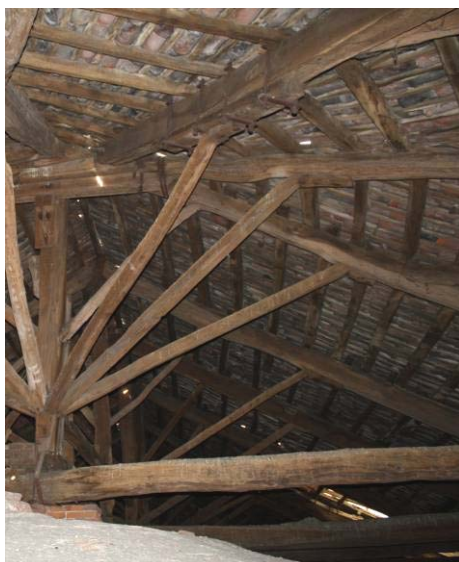
Figure 10: Elements of the roof timber structure over the apse of the Cathedral of Vercelli Overall state of conservation

Concerning the trusses object of the survey, an overall good state of conservation is present, except for some fungus and insects attack limited to portions of sapwood in some timber elements. In any case the insects attack had ended since a lot of time.

In general, tie-beams are more decayed than rafters. This is probably due to material (i.e. concrete, pieces of tiles and bricks) that fills the space between the heads of the trusses and the masonry. This material becomes wet after rainwater leaking and provokes a high moisture content in wood that is therefore more subject to xilofagus fungus attack.

With the aim of bringing back thermo-hygrometric conditions of wood below the limit that is favourable to fungus attack, is indicated to facilitate air circulation around the wooden parts inside the masonry, so that it will be possible to reach better moisture conditions.

It is also advisable an accurate cleaning of the horizontal timber elements with the removal of dust and various deposits.

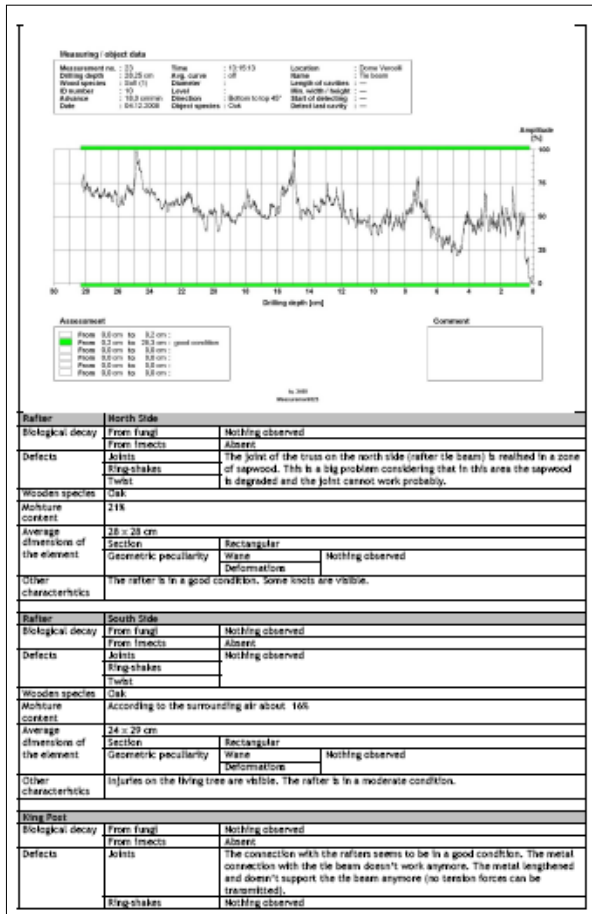
Twist	
Wooden species	Oak	
Moisture content	According to the surrounding air about 16%	
Average dimensions of the element	26 x 20 cm	
	Section: Rectangular	
	Geometric peculiarity: Wane	Knot and wane
	Deformation: ---	
Other characteristics	The post is not lined up with the tie beam. The horizontal connections joining the king posts with each other caused a displacement of the timber element. The king post is in a moderate condition.	
PHOTO		
n. Photo	IMG_0588 Truss 3	IMG_7056 Knot (king post - rafter)
PHOTO		
n. Photo	IMG_0715 Knot (king post - chord member)	IMG_0716 / IMG_0717 Knot (rafter - chord member)
PHOTO		
n. Photo	IMG_0546 / IMG_0547 Knot (rafter - tie beam) South side	IMG_0674 IMG_0723 Knot (rafter - tie beam) North side

3.12.08	R 15	front end south side	perpendicular air to grain
			Drill 15 (executed on soft timber): the test has been taken perpendicular to grain on the tie beam. There are only 6cm of good timber, after that there is nearly no resistance. <u>The result couldn't have been much worse.</u>
PHOTO

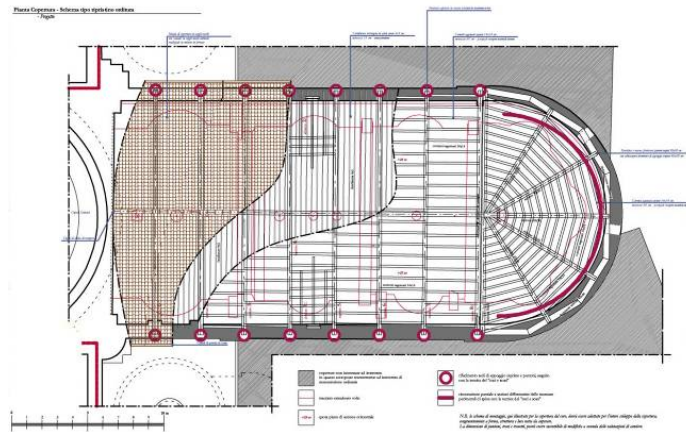
Figure 13: Plan of the presbytery-choir. Scheme of the restoration project for the roof structure.

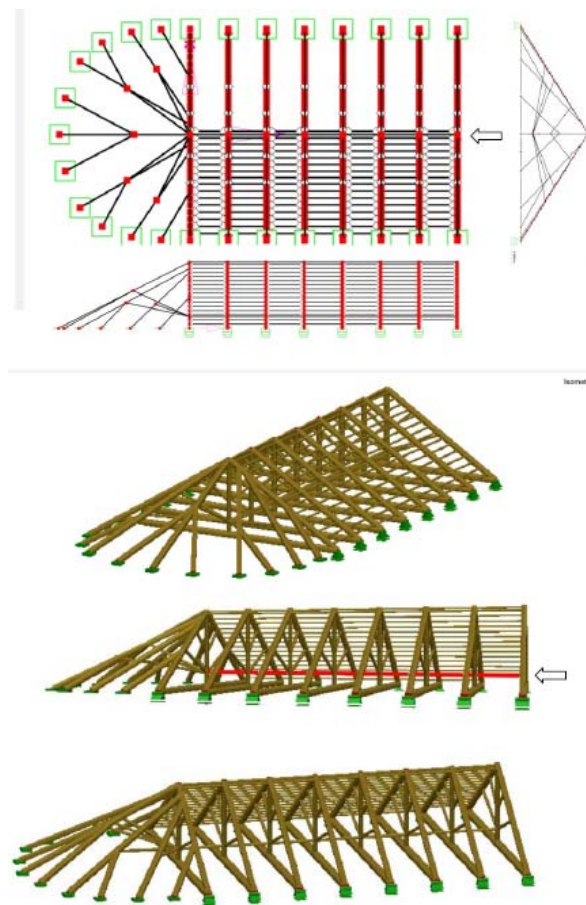
Figure 14: Sketches of intervention proposal
