Learning from a case study: the great timber roof structures of the Cathedral of Vercelli

Clara Bertolini Cestari¹, Gianoreste Biglione², Luciana Cestari³, Germana Corradino⁴, Alan Crivellaro⁵, Daniele De Luca⁶, Tanja Marzi⁷, Pia Panosch⁸, Riccardo Pasquino⁹

Keywords diagnosis, survey, timber grading, conservative restoration

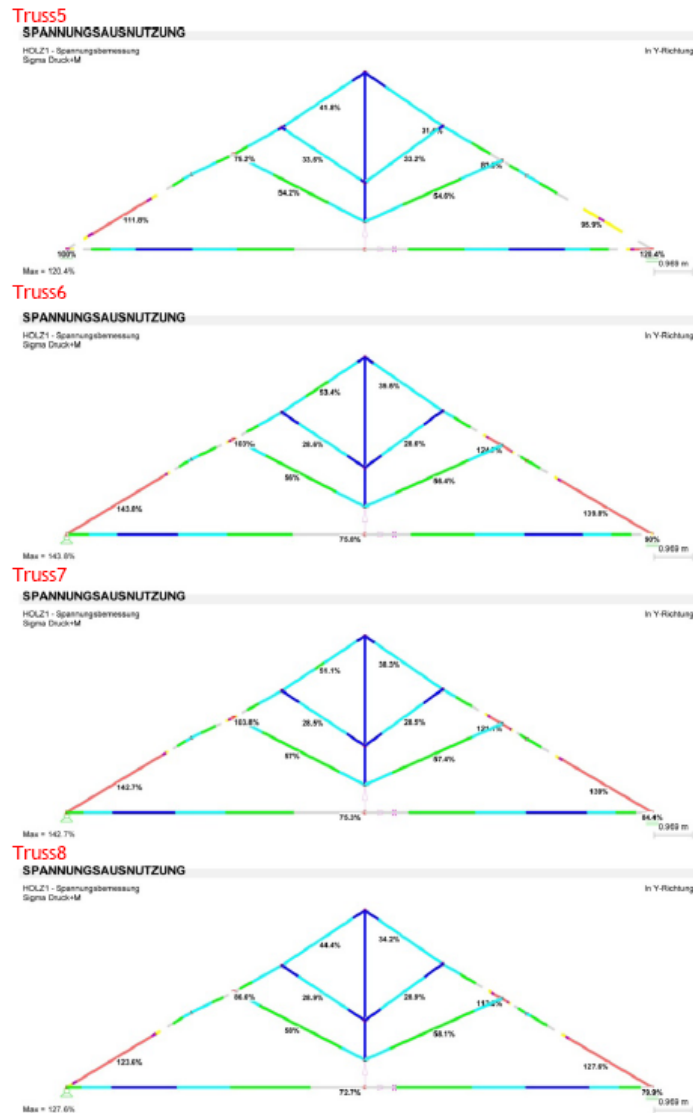
Figure 9 – Structural models reporting decays and defects of the components (stress in the lower part of the rafters is generally a too high)

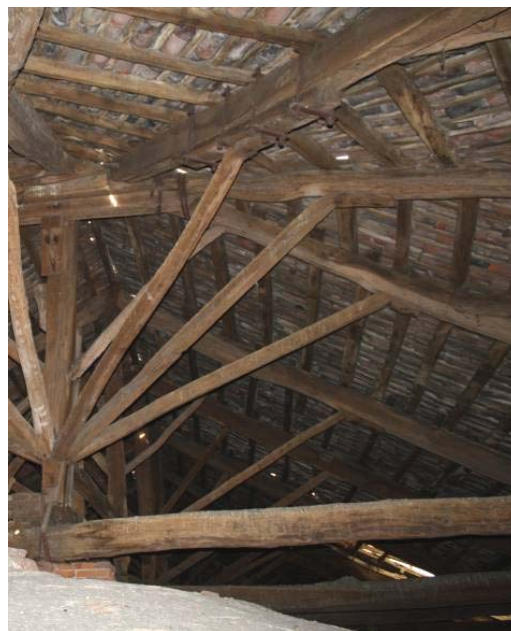
Figure 10 – Elements of the roof timber structure over the apse of the Cathedral of Vercelli Overall state of conservation

Concerning the trusses object of the survey, an overall good state of conservation is present, except for some fungi and insects attack limited to portions of sapwood in some timber elements.

In general, tie-beams are more decayed than rafters. This is probably due to material (i.e. concrete, pieces of tiles and bricks) that fills the space between the heads of the trusses and the masonry. This material becomes wet after rainwater leaking and provokes a high moisture content in wood that is therefore more subject to xilofagus fungus attack.

The results of the visual grading of the timber elements of the examined trusses have been integrated with the instrumental analysis carried on in the timber parts included inside the masonry walls. With the aim of bringing back thermo-hygrometric conditions of wood below the limit that is favourable to fungus attack, is indicated to facilitate air circulation around the wooden parts inside the masonry, so that it will be possible to reach better moisture conditions. It is also advisable an accurate cleaning of the horizontal timber elements with the removal of dust and various deposits.

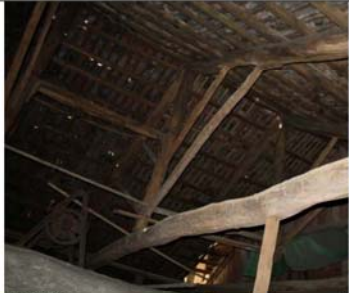
Biological decay	From fungi	Present in the part inside the masonry.	
	From insects	Absent	
Defects	Joints	The connection with the rafters seems to be in a good condition. The metal connection with the tie beam doesn't work anymore. The metal lengthened and doesn't support the tie beam anymore (no tension forces can be transmitted).	
	Ring-shakes		
	Twist		
Wooden species	Oak		
Moisture content	According to the surrounding air about 16%		
Average dimensions of the element	22 x 23 cm		
	Section	Rectangular	
	Geometric peculiarity	Wane	Knot and wane
Other characteristics	The post is not lined up with the tie beam. The horizontal connections joining the king posts with each other caused a displacement of the timber element. The presence of the tenon in the connection with the tie-beam is evident in profiles 36a and 38a. From the profiles are not visible particular decay signs.		
PHOTO

n. Photo	IMG_0687 Truss 2	IMG_0730 Knot (king post - rafter)
PHOTO

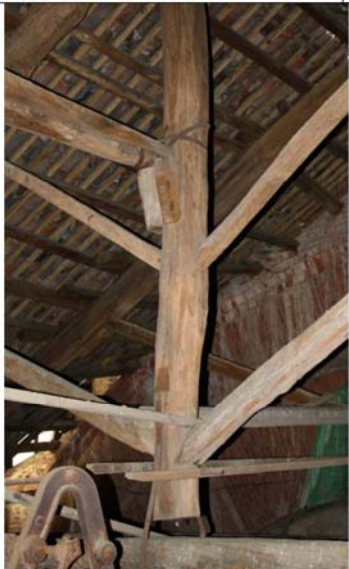
n. Photo	IMG_0729 Knot (king post - chord member)	IMG_0731 / IMG_0732 Knot (rafter - chord member)
