## Characterization of Carved Rhyolite Tuff—The Hieroglyphic Stairway of Copán, Honduras

E. Doehne<sup>1\*</sup>, S. Simon, U. Mueller<sup>2</sup>, D. Carson and A. Ormsbee

### Abstract

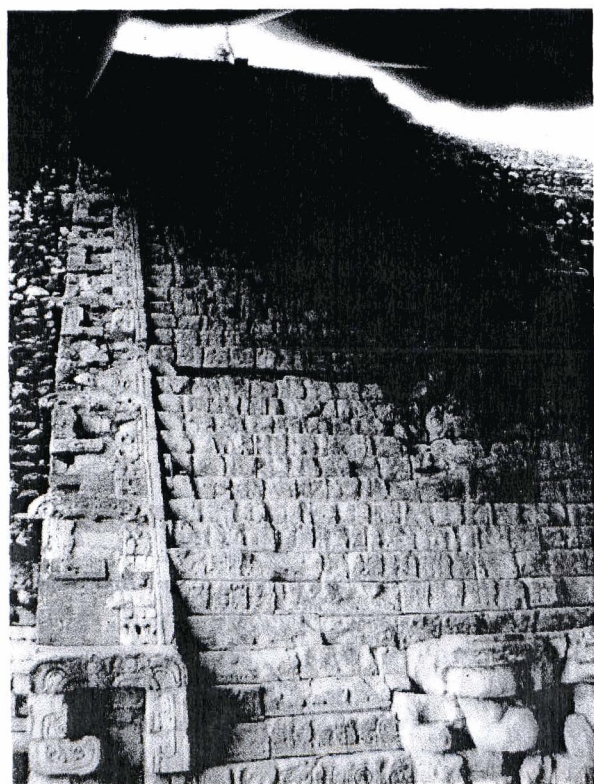
The Hieroglyphic Stairway at the ancient Mayan site of Copán, Honduras, was built during the 8<sup>th</sup> century C. E. Carved on its risers is the longest known inscription from ancient Mesoamerica, a unique historical account of four centuries of the Copán dynasty [1]. Over the years, the deterioration of the volcanic tuff, mainly through millimeter-scale flaking, has been a major cause of concern because it directly impacts the readability of the carved text [2]. A joint project of the Instituto Hondureño de Antropología e Historia and the Getty Conservation Institute was initiated to establish a long-term conservation strategy for the Stairway. A tarp first installed in 1985 currently shelters the stairway (Fig. 1).

Figure 1: The Hieroglyphic Stairway, with shelter, April 2000

As can be seen from the WUFI results, the presence of the tarp would significantly reduce the stone temperature fluctuations and surface moisture content. The tarp currently prevents the regular wetting of the Copán Hieroglyphic Stairway and is

expected to substantially reduce the potential for damage from shear stress resulting from the stone surface wetting and swelling (due to the presence of swellable clay and organic materials) while the interior of the stone remains dry. The slow water transport characteristics of the stone and the surface parallel nature of the stone loss are consistent with this type of decay mechanism. Ongoing monitoring of surface stone stability will address the longer-term impact of the tarp.

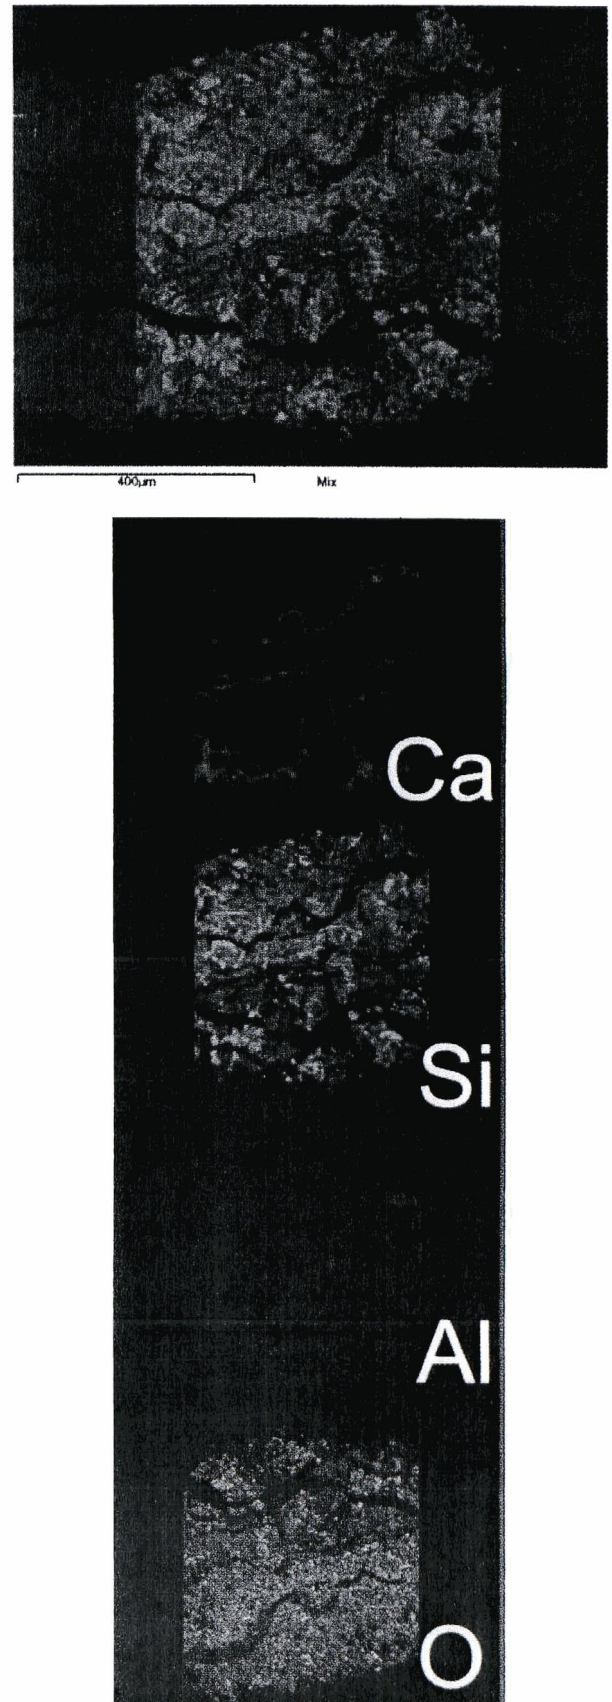
Often, below detached flakes, whitish efflorescences are observed at the stairway. The cross section of the flake shows surface parallel cracks, which are filled partly with white crystals. In UV light, the filling material is more fluorescent, suggesting incorporation of organic material, which is frequently found in patinas. The analysis in ESEM-EDS reveals a precipitation of calcite along those cracks (Fig. 2), which was confirmed by XRD analysis. Furthermore the bottom of the flakes, in the more crumbly horizon of detachment,

**Figure 2:** ESEM/EDS image of Copán stone flake in BSE mode with X-ray overlay showing distribution of calcite in fractures (false color-red). Scale is 400 microns.

is depleted in silicon (Si) and oxygen (O), suggesting a selective dissolution of these components in the course of weathering. This general pattern is visible in several stone flakes.

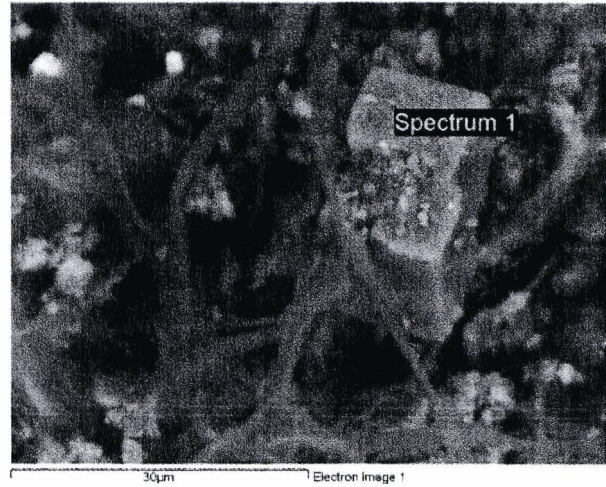
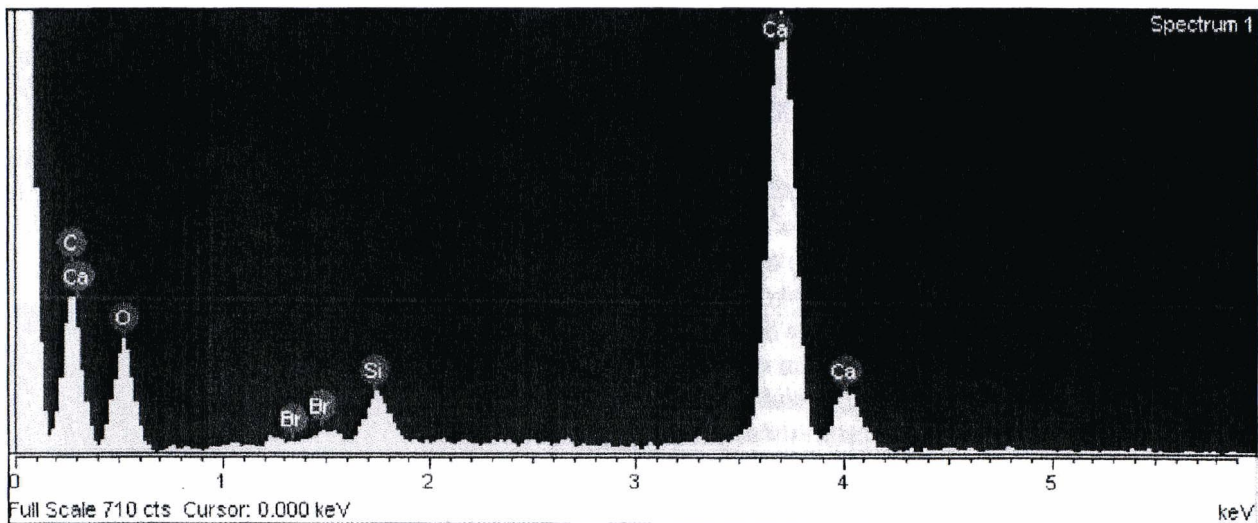
Often the cracks in the flakes are also filled with organic material, including remnant fungal hyphae, which sometimes can be associated with calcite formation (Fig. 3) [3]. However, the origin of the surface parallel cracks cannot be clarified completely. They could also be the result of subsequent wetting-drying cycles, associated with hygric dilatation of the immediate surface, dissolution of more soluble stone components and sheer stress. In fact, the thickness of the flakes corresponds quite well to the depth position of the maximum moisture content for Copán stone in average over time (see section C below).

Figure 3 a: Copán stone flake with calcite and fungi on flake surface, ESEM/EDS.

Figure 3 b: Element analysis at detail shown in Fig. 3 a

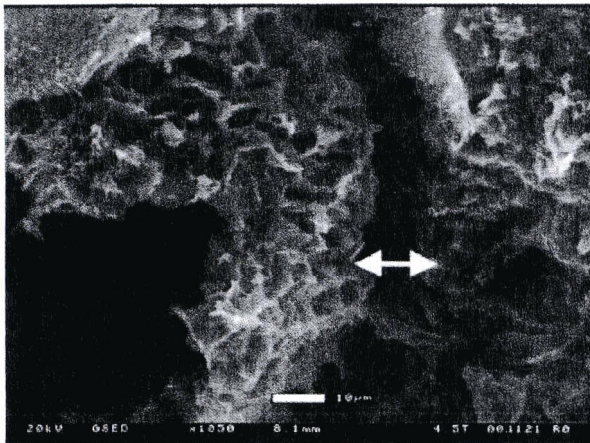
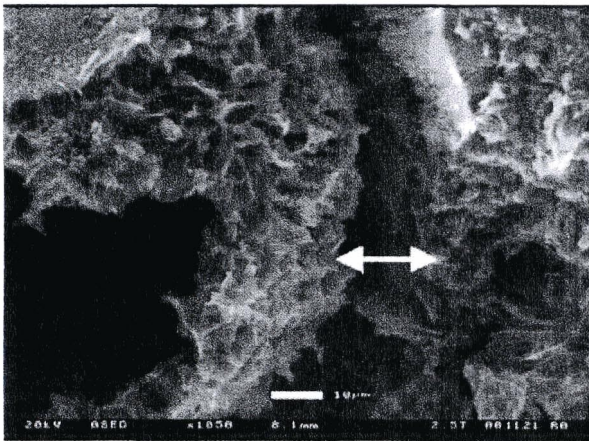
Often when a stone is put into water it swells slightly. If significant amounts of swellable clays are present then the expansion can be a cause of physical stress and an important factor in the decay process. The bulk hygric dilatation was measured for three Copán stones (buff, fine green and coarse green). Analysis of the fine fraction showed a small amount of swellable clays present (2-6 %). The results show that the dilatation (expansion) of

**Figure 4 a; b:** Expansion and contraction of clay in ESEM during wetting-drying cycles, sample BF1.

Copán stone is within the range expected for this stone type, however there is substantial variation depending on the sample orientation and lithology (250-590  $\mu\text{m}/\text{m}$ ). If the clay is not distributed evenly throughout the stone, but is concentrated in specific zones; then clay swelling may be important source of stress especially on a microscale (Fig. 4). Shear stress may also develop as the stone surface wets and dries at a different rate than the bulk stone.

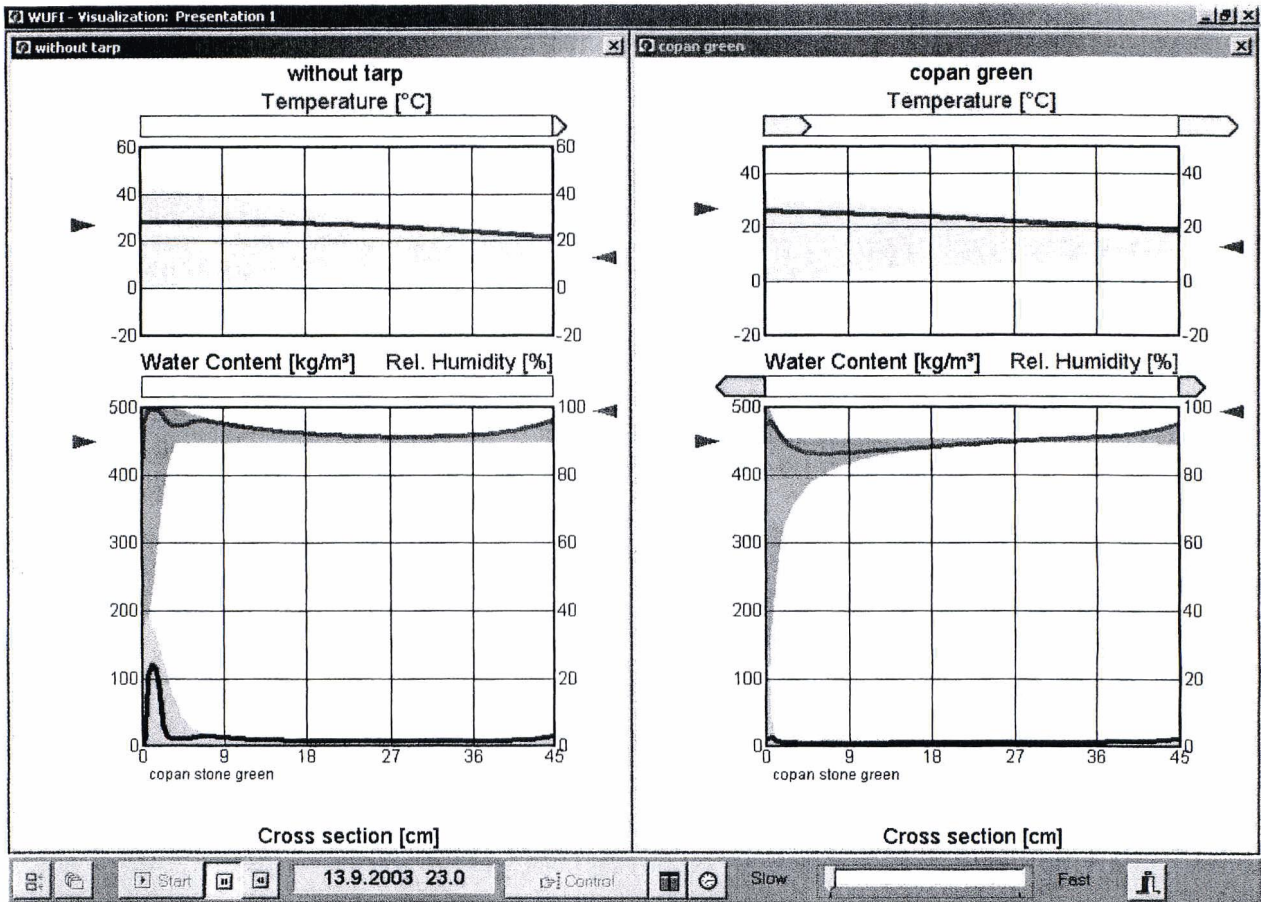
**Figure 5:** WUFI-Calculation for depth profiles of water content, relative humidity and temperature for the Copán staircase (green stone) with (right) and without (left) the tarp.

Based on the measured physico-mechanical properties of the stone, the moisture and temperature profiles were calculated using the program WUFI which was developed for the calculation of simultaneous heat and moisture transport (Fig. 5) [4]. Two situations are compared with each other: On the right (Fig. 5), the stairway under the current conditions, on the left the unsheltered situation without the tarpaulin. In yellow the calculated temperature depth profiles are given on the top, below in green the relative humidity and in blue on the bottom, the water content. The lines do not represent the average, but the final state at the end of the annual cycle. The colored areas stand for the sum of all curves and illustrate the range covered in a typical year.
