INVESTIGATIONS INTO DECAY MECHANISMS OF MAGNESIAN LIMESTONE AT CHAPTER HOUSE, HOWDEN MINSTER

David Odgers¹, Sarah Pinchin², Bill Martin², Chris Wood², Tobit Curteis³, Eric Doehne⁴, Giacomo Chiari⁴, Jeanne Marie Teutonico⁴, Ann Bourges⁵

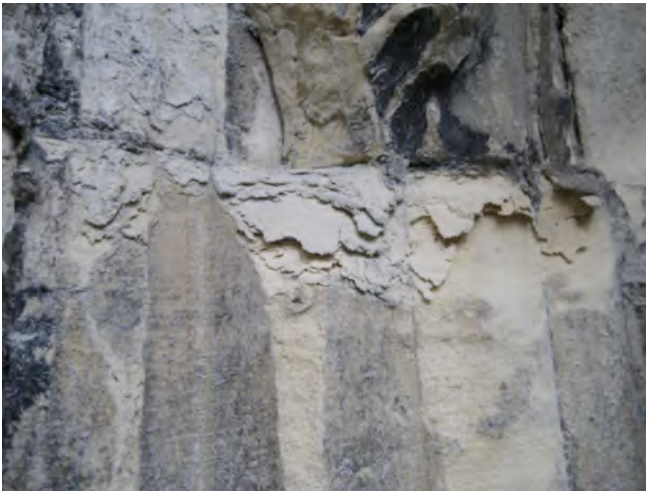
Figure 1: Detail of the flaking stone on the Northwest wall.

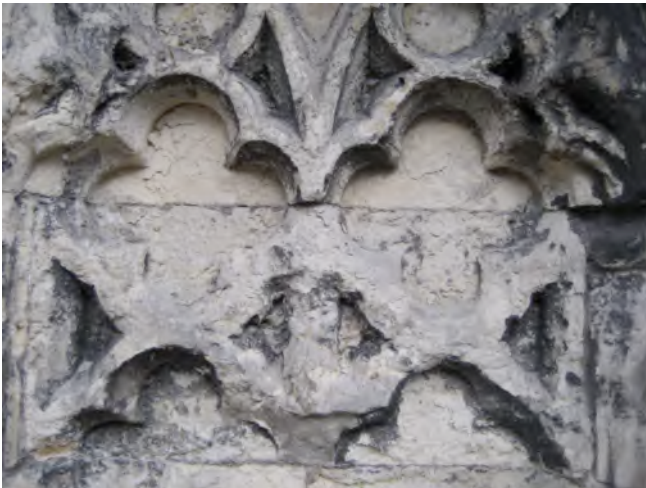
Figure 2: Detail of the surface blistering on the East wall.

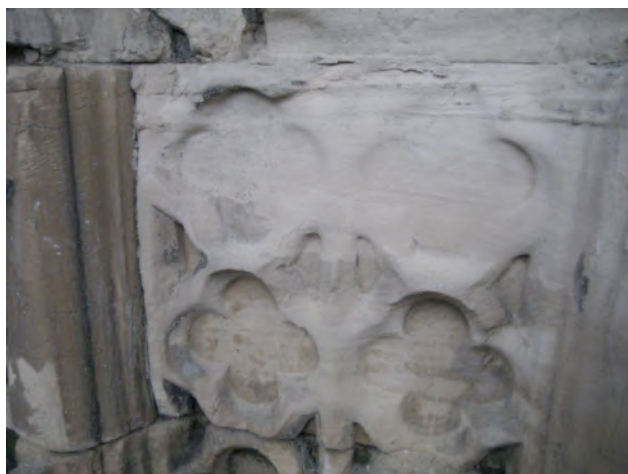
Figure 3: Detail of soft erosion on the North wall.

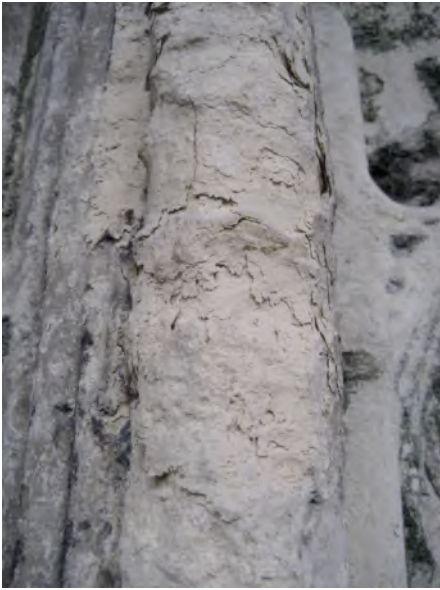
Macro photographs of the highlighted areas are taken at six-month intervals, recording when new flakes occur. A field time-lapse camera records damage as it is occurring. Stone loss events and the creation of new flakes appear to correlate with environmental changes such as high winds and condensation. The time-lapse sequence records the creation of new flakes and the loss of existing flakes which do not occur uniformly over the stone surface but rather in precise locations.

Figure 4: Macro photograph of flaking column on West wall.

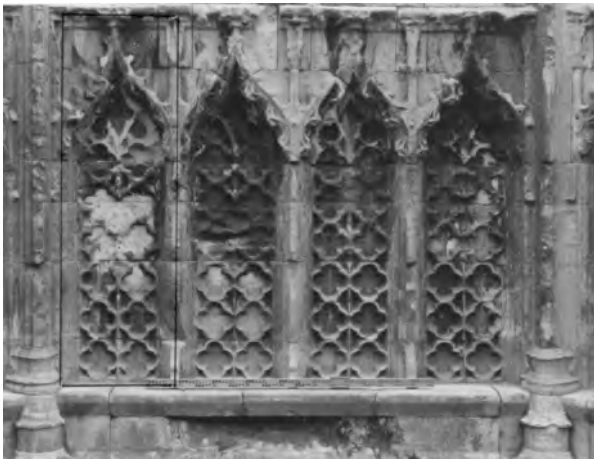
The patterns and progression of decay can be traced with photographic evidence. Photographs taken prior to the reroofing in 1984 show that extensive damage to the surface topography has occurred in the last twenty-four years. Photographs from 1980 reveal that the surface has undergone significant damage following this intervention.

Figure 5: Photograph showing the extent of deterioration on the interior Northwest wall in June 1980.

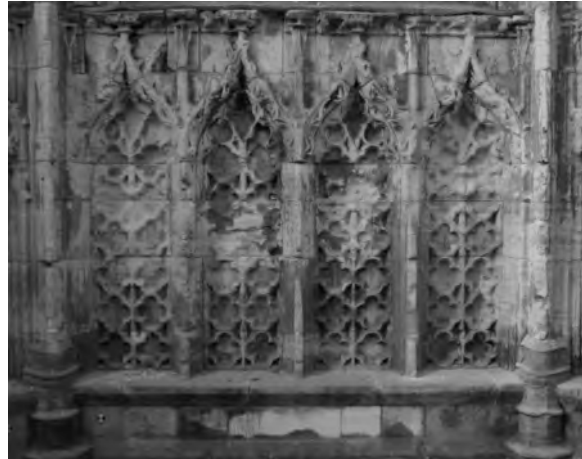
Figure 6: Photograph showing the extent of deterioration on the same wall in June 2007.
