CHARACTERIZATION OF CARVED RHYOLITE TUFF—THE HIEROGLYPHIC STAIRWAY OF COPÁN, HONDURAS

Eric Doehne, Stefan Simon, Urs Mueller¹, David Carson, & Alice Ormsbee

*The Getty Conservation Institute
1200 Getty Center Drive, Suite 700
Los Angeles, CA 90049
Tel. (310) 440-6237
FAX (310) 440-7711
EDoehne@getty.edu*

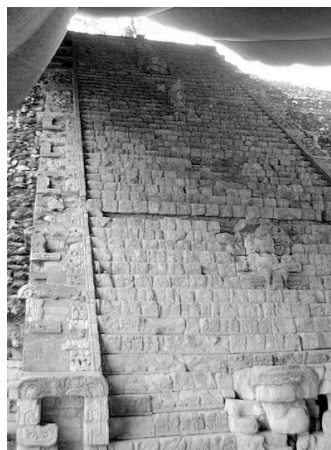
Figure 1: The Hieroglyphic Stairway, with shelter, April 2000

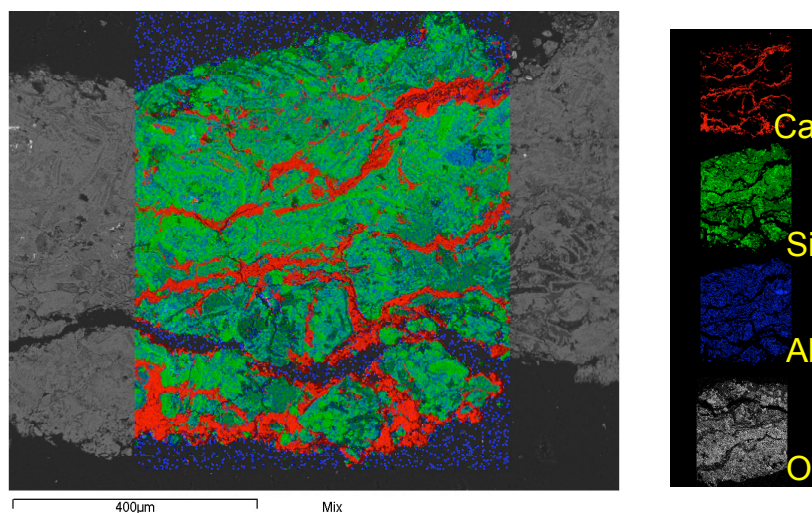
Often, below detached flakes, whitish efflorescences are observed at the stairway. The cross section of the flake shows surface parallel cracks, which are filled partly with white crystals. In UV light, the filling material is more fluorescent, suggesting incorporation of organic material, which is frequently found in patinas. The analysis in ESEM-EDS reveals a precipitation of calcite along those cracks (Fig. 2), which was confirmed by XRD analysis. Furthermore the bottom of the flakes, in the more crumbly horizon of detachment, is depleted in Silicon and Oxygen, suggesting a selective dissolution of these components in the course of weathering. This general pattern is visible in several stone flakes.

Figure 2. ESEM/EDS image of Copán stone flake in BSE mode with X-ray overlay showing distribution of calcite in fractures (false color-red). Scale is 400 microns.

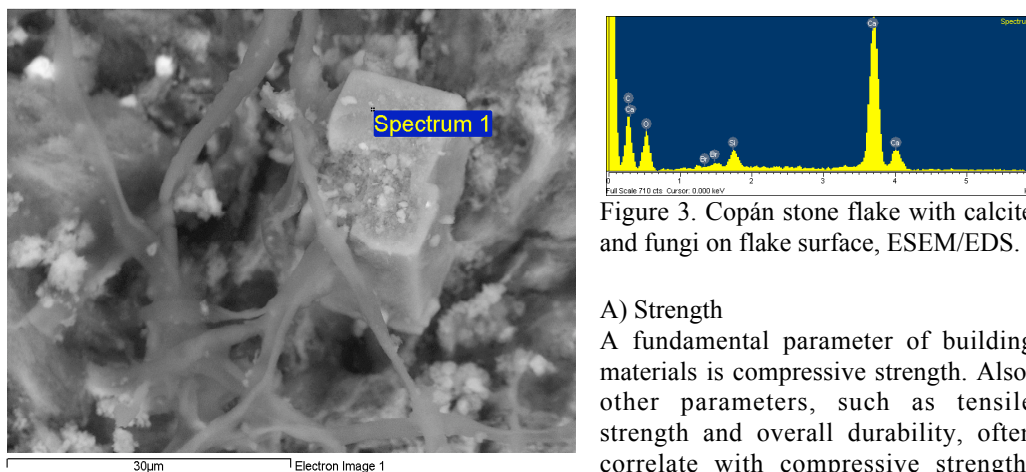
Often the cracks in the flakes are also filled with organic material, including remnant fungal hyphae, which sometimes can be associated with calcite formation (Fig. 3; Chen 2000). However, the origin of the surface parallel cracks cannot be clarified completely. They could also be the result of subsequent wetting-drying cycles, associated with hygric dilatation of the immediate surface, dissolution of more soluble stone components and shear stress. In fact, the thickness of the flakes corresponds quite well to the depth position of the maximum moisture content for Copán stone in average over time (see later discussion).

Figure 3. Copán stone flake with calcite and fungi on flake surface, ESEM/EDS.

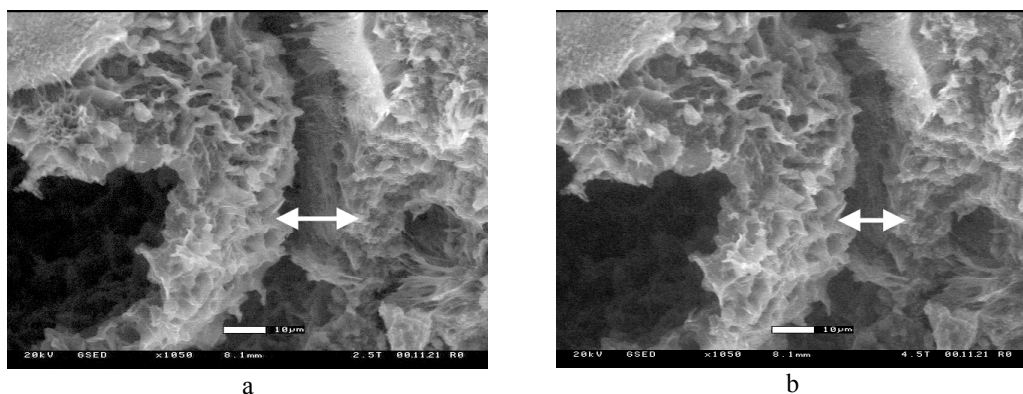
Often when a stone is put into water it swells slightly. If significant amounts of swellable clays are present then the expansion can be a cause of physical stress and an important factor in the decay process. The bulk hygric dilatation was measured for three Copán stones (buff, fine green and coarse green). Analysis of the fine fraction showed a small amount of swellable clays present (2-6%). The results show that the dilatation (expansion) of Copán stone is within the range expected for this stone type, however there is substantial variation depending on the sample orientation and lithology (250-590 $\mu\text{m}/\text{m}$). If the clay is not distributed evenly throughout the stone, but is concentrated in specific zones; then clay swelling may be important source of stress especially on a microscale (Fig. 4). Shear stress may also develop as the stone surface wets and dries at a different rate than the bulk stone.

Figure 4 a,b. Expansion and contraction of clay in ESEM during wetting-drying cycles, sample BF1.

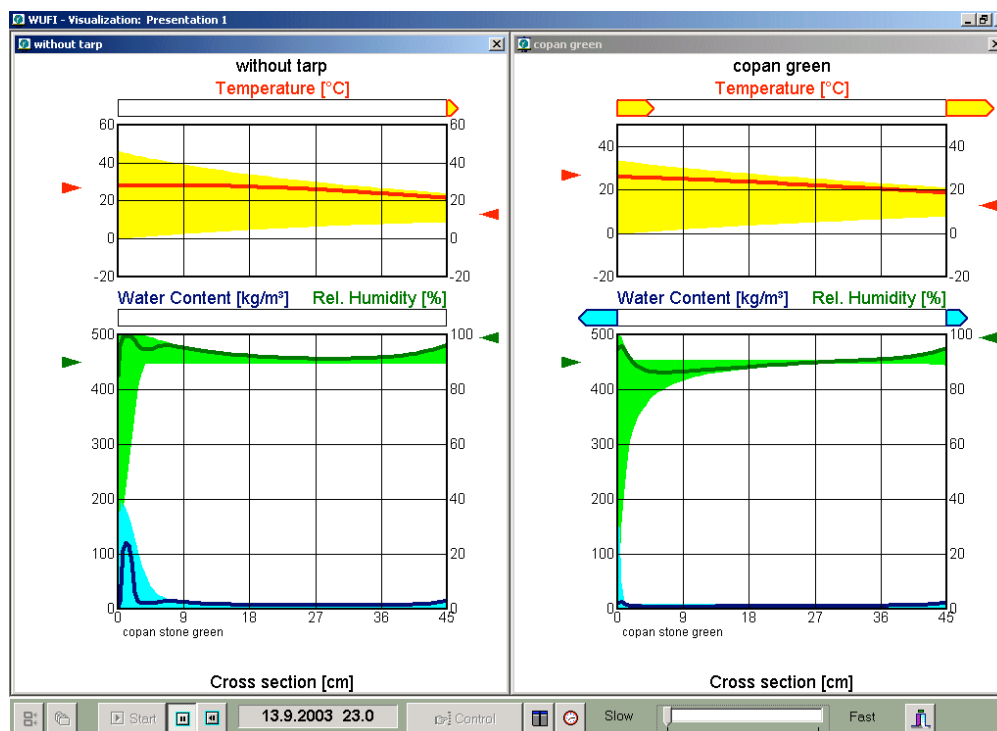
Based on the measured physico-mechanical properties of the stone, the moisture and temperature profiles were calculated using the program WUFI which was developed for the calculation of simultaneous heat and moisture transport (Fig. 5; Künzle 1995; Fraunhofer Institute for Building Physics). Without the current tarp over the stairway (Fig. 1), the stone

surface would likely contain up to 40 kg/m³ water (Fig. 5, left), while under the shelter, a continuous drying process takes place (Fig. 5, right). These results represent the first comprehensive characterization of Copán stone and contribute to the selection of appropriate repair materials and the development of a comprehensive conservation plan for this important monument.

Figure 5. WUFI-Calculations for depth profiles of water content, relative humidity and temperature for the Copán staircase (green stone) with (right) and without (left) the tarp.
