RECONSTRUCTION OF A MOTORCYCLE HEAD-ON COLLISION - CZECH REPUBLIC CASE STUDY

Nabhan Khatib, Marek Semela, Aleš Vémola

Institute of Forensic Engineering, Brno University of Technology, CZE

This paper discusses mainly a reconstruction of a motorcycle head-on collision; where a solution of a specific accident will be shown – head-on collision of two motorcycles, which happened in Czech Republic. Also an overview of traffic statistics in Czech Republic is discussed as well; since there are no specific traffic statistics for motorcycle itself then general statistics will be shown.

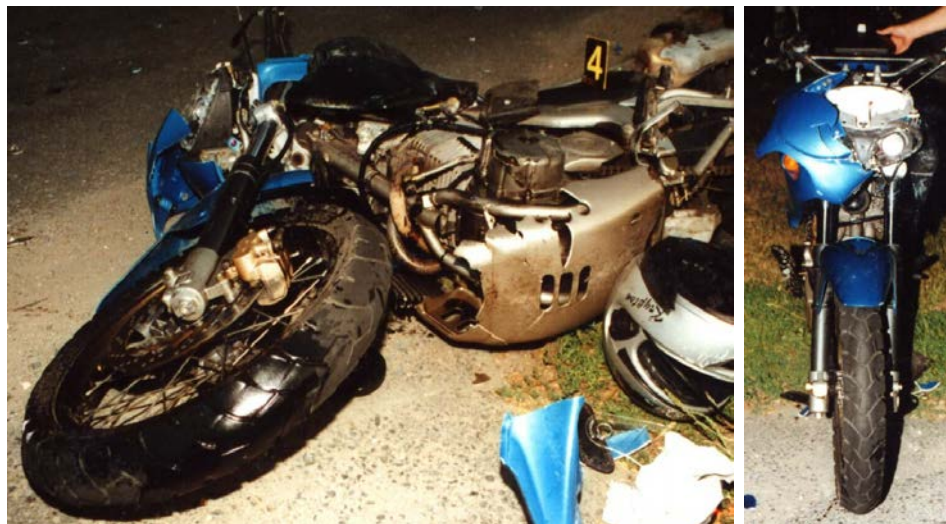
Fig. 4 Damage on Cagiva

According to the report, damage to the Cagiva motorcycle related to both front directional lights, tank, seat, front fairing, headlight, dashboard, both mirrors, handlebars, handgrips, small lever of clutch, front fender, oil cooler, engine block on the left side, gearshift lever and crampons and other possible damage was not excluded. According to the report, damage to the Honda motorcycle related to directional front lights, headlight, front rim, front fender, front fork, dashboard, mirrors, front brake lever and other possible damage was not excluded as well.

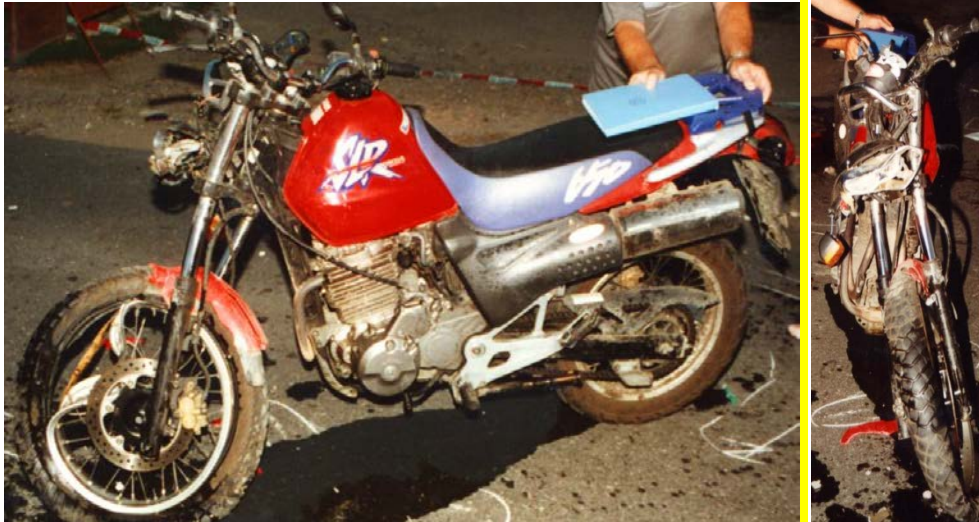
Fig. 5 Damage on Honda

The measurement of the damaged Honda motorcycle resulted in that the wheelbase was shortened approximately about 0,18 metre. For estimation of range of EES may be considered shortening of the wheelbase within technically acceptable range from 0,17 to 0,21 m. After shortenings are recorded in the chart in **Fig. 6**, which was compiled from results of crash tests in Germany, it may be concluded that technically acceptable range of EES lies between 39 and 43 km/h (also compared to [11]).

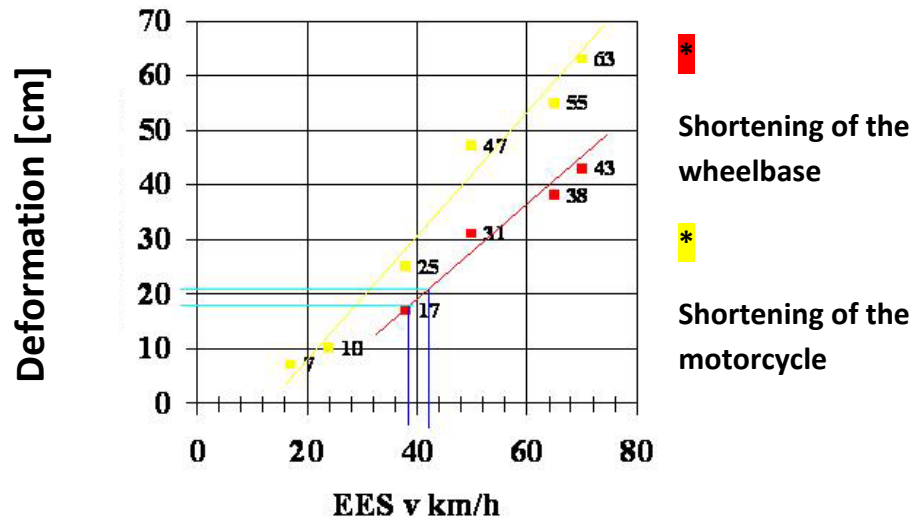
Fig. 6 Estimation of EES (Honda) from shortening the wheelbase, according to literature [10]
