## THE DAMAGE MECHANISM OF SODIUM SULFATE IN POROUS STONE

E. Doehne<sup>1</sup>, C. Selwitz<sup>2</sup>, and D. Carson<sup>1</sup>

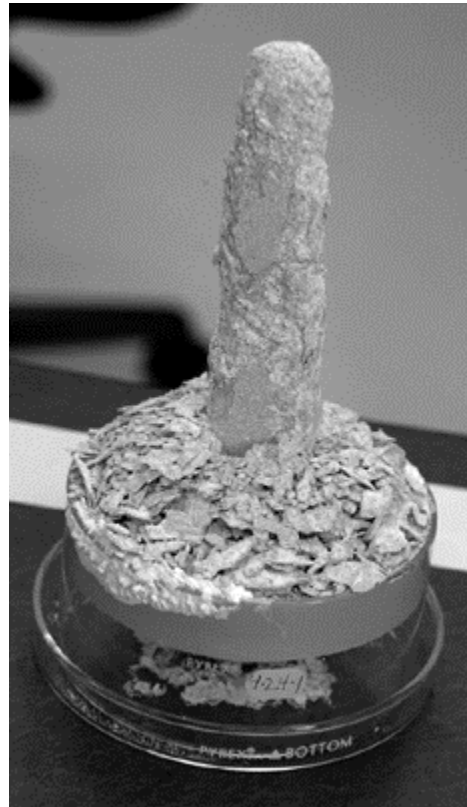
Figure 10. Bath limestone block after exposure to 20% solution of sodium sulfate in low air exchange environment, 3 months. Note extensive efflorescence of mirabilite.

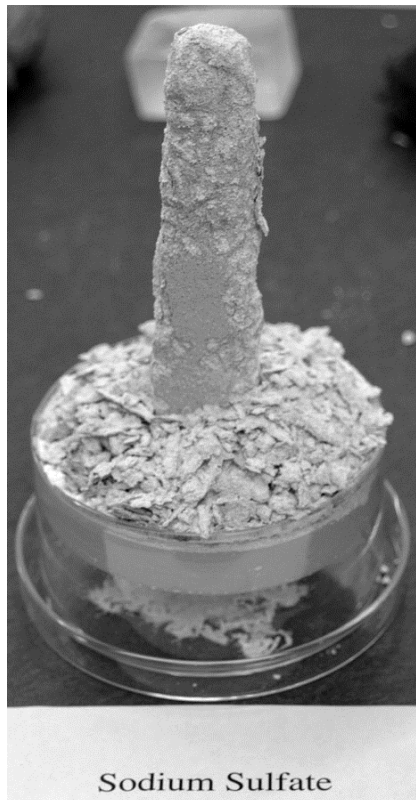
Figure 12. Opposite side of Bath limestone block after exposure to 20% solution of sodium sulfate in high air exchange environment (10x/hr). Note pile of scales at base of sample.
