**TIME-LAPSE MACRO-IMAGING IN THE FIELD:
MONITORING RAPID FLAKING OF MAGNESIAN LIMESTONE**

E. Doehne¹, S Pinchin²

Abstract

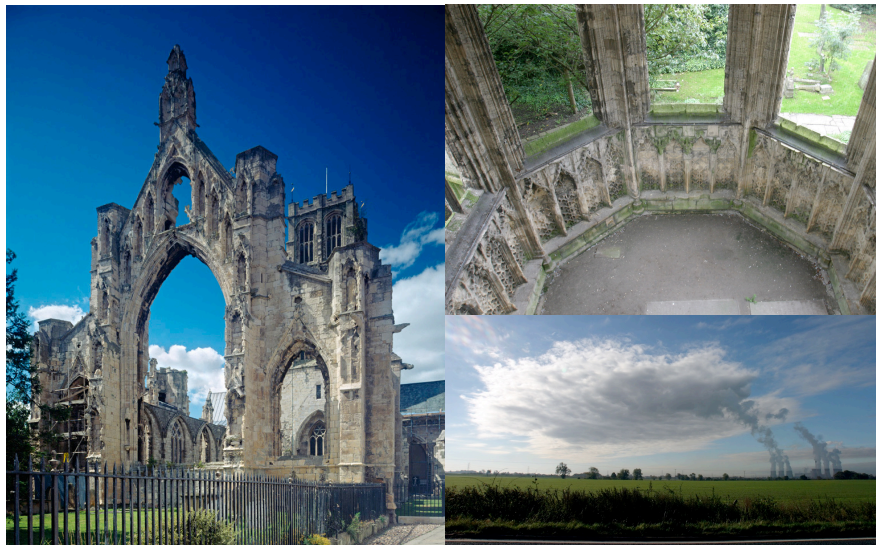
Figure 1. Figure 1a,b, c. Howden Minster ruin, chapter house (ca. 1388), and nearby Drax, the second largest coal-fired power station in Europe.

An important question in stone conservation is whether material damage takes place as continual process or an episodic event. In other words, does damage take place due to an accumulation of everyday environmental stress or is most damage caused by relatively rare extreme environmental changes? Answering this question has important implications for preventive conservation strategies. For example, some types of rare events may be more easily mitigated by efforts to buffer environmental extremes such as thermal stress (Viles and Wood, 2007). This is precisely what English Heritage and the Getty Conservation Institute are trying to achieve at the site of Howden Minster, a 14th century ruin located in East Yorkshire, England, where the magnesian limestone is suffering from severe flaking (Pinchin et al., 2008)(Fig. 1).

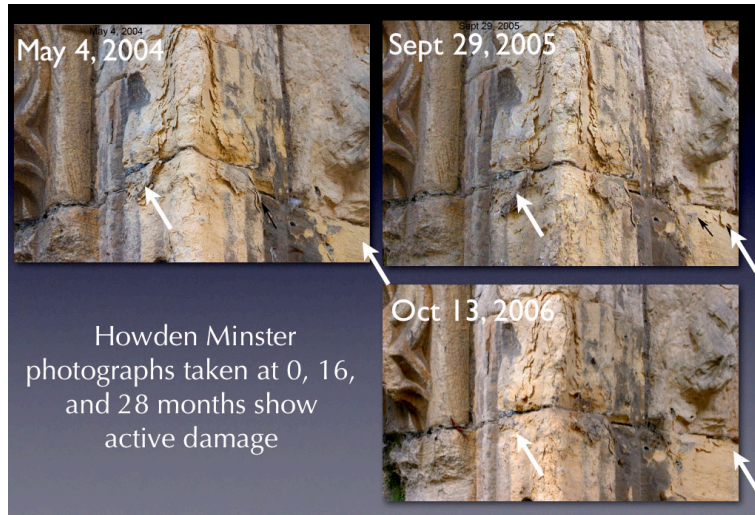
Figure 2. Results from repeat photography showing the creation of new flakes and the loss of old flakes over a period of 28 months documents active damage to Magnesian Limestone.

The site is located 27 km south-east of York and 7 km downwind from Drax, a large coal-fired powerplant. Annual macro photography of the stone over a three-year period had demonstrated the creation of new flakes and the loss of existing flakes (Fig. 2), yet the degradation mechanism needed further examination in order to answer the questions

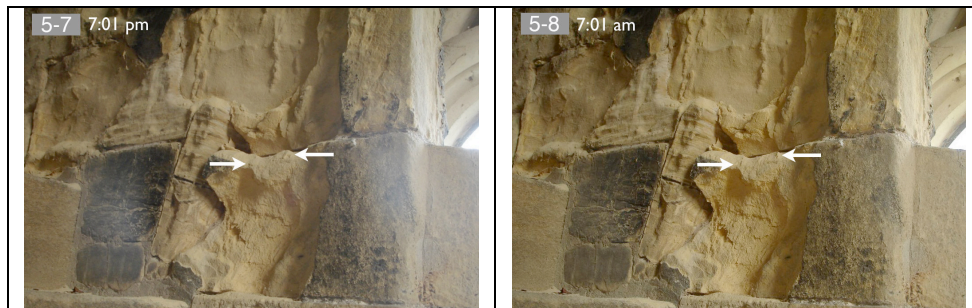
Figure 5. Two time-lapse images showing an episodic loss event on May 8, 2006 with loss of stone surface taking place at white arrows.

In the case of the damage observed on May 8, 2007 a check of the University of York weather database shows high winds in the area on this date, with a maximum wind speed of 34.7 mph in York. The lack of a weather station at Howden itself limits this comparison and a weather station has now been installed at the site. At least a year's worth of image and climate data is needed to better correlate the stone surfaces losses with microclimate patterns. The fact that some loss events correlate with high winds, may indicate a correlation with increase drying rates and thus salt solution supersaturation in sheltered areas (Espinosa Marzal and Scherer, 2008; Genkinger and Putnis, 2007; Rodriguez-Navarro and Doehne, 1999). It should be noted that the stairwell site at Howden is well sheltered from rain, however the stairwell acts as a venturi, especially in windy conditions.

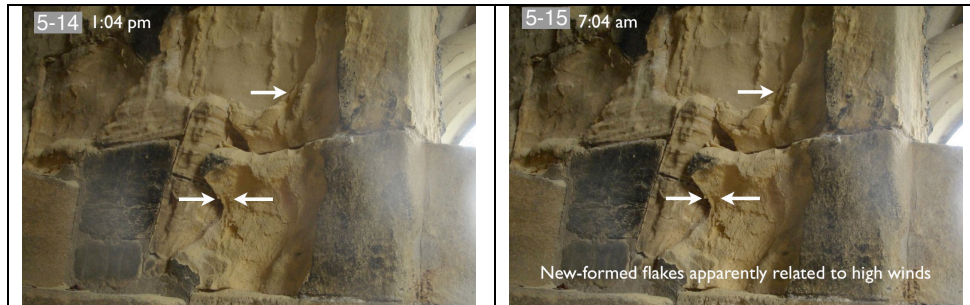
Figure 6. Two time-lapse images showing the episodic loss event seven days later than in Figure 5 with new losses taking place at white arrows (May 15, 2007).

One question not originally posed, but interesting nonetheless is if damage in different stones is synchronous? In other words, does the damage occurring within the field of view of the camera take place at the same time, or does it depend on the variations in the stone, or is it simply random? Observations at Howden thus far show that the damage only affects a small portion of the field of view, but the damage that does occur is indeed synchronous. That is, it occurs over a discrete interval of a few hours in different parts of the field of view that are separated by tens of centimeters and in several cases are on different blocks of stone. Therefore, this may suggest that the dominant factors in damage at this site are a combination of environmental condition and local salt concentration, rather than inherent vice or variation in the substrate.
