# HIDDEN ARCHITECTURE. RESTORATION OF HISTORIC TIMBER STRUCTURES: THE GREAT ROOF STRUCTURES OF THE CATHEDRAL OF VERCELLI

Clara Bertolini Cestari  
Gianoreste Biglione  
Politecnico di Torino  
Dipartimento di Progettazione  
Architettonica e di Disegno Industriale  
Viale Mattioli 39  
10125 Torino]  
Italy  
[clara.bertolini@polito.it](mailto:clara.bertolini@polito.it)

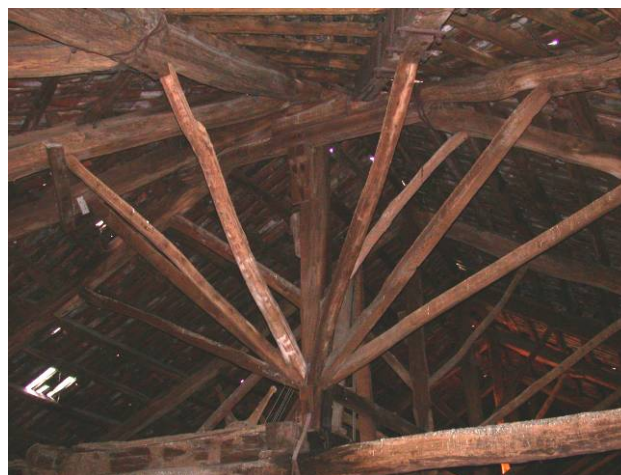
Figure 1: Elements of the roof timber structure over the apse of the Cathedral of Vercelli Grading according to resistance

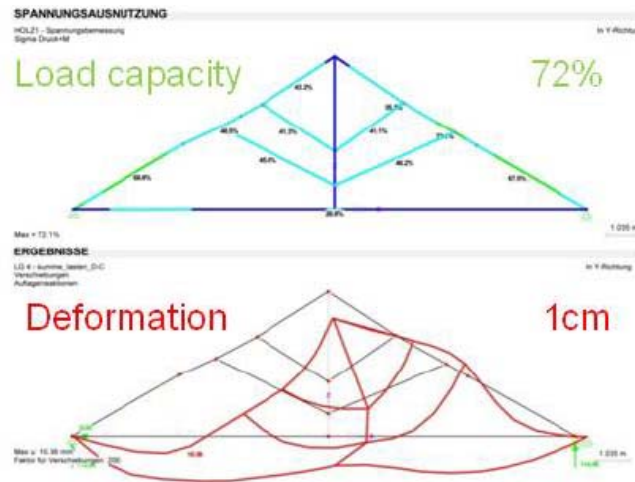
Figure 7: Results for the load case D-C (highest loads)

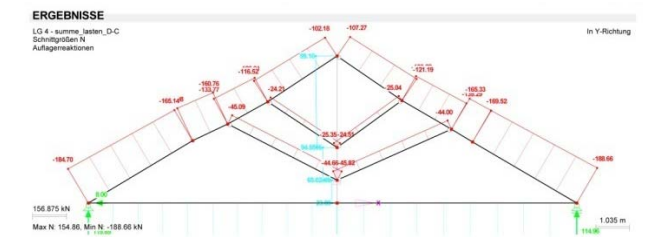
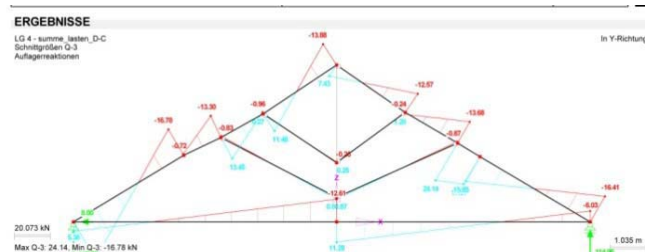
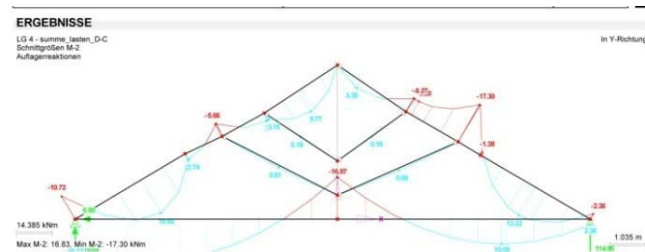
Figure 8: Axial force working on the beams (a); shear force working on the beams (b); axial force working on the beams (c).
