Learning from a case study: the great timber roof structures of the Cathedral of Vercelli

Clara Bertolini Cestari¹, Gianoreste Biglione², Luciana Cestari³, Germana Corradino⁴, Alan Crivellaro⁵, Daniele De Luca⁶, Tanja Marzi⁷, Pia Panosch⁸, Riccardo Pasquino⁹

Keywords diagnosis, survey, timber grading, conservative restoration

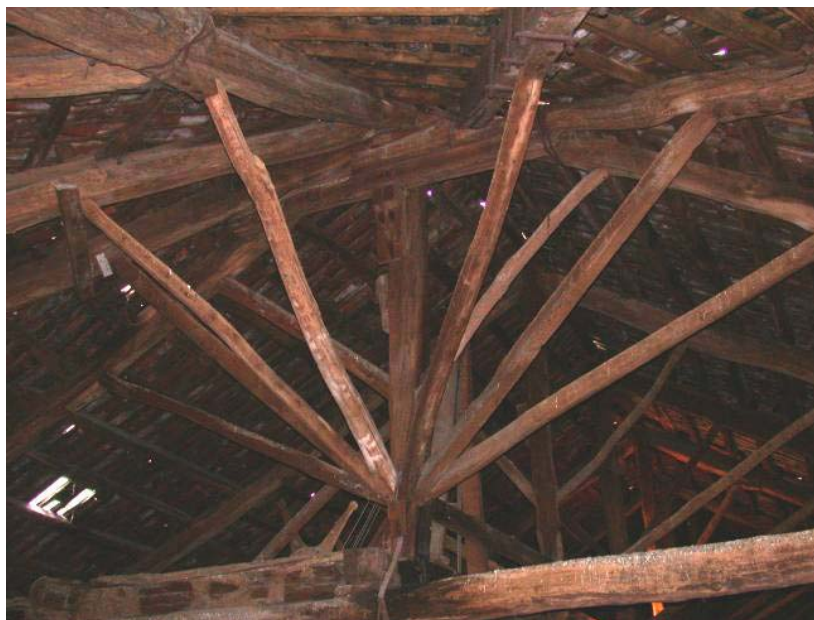
Figure 1 – Elements of the roof timber structure over the apse of the Cathedral of Vercelli Grading according to resistance

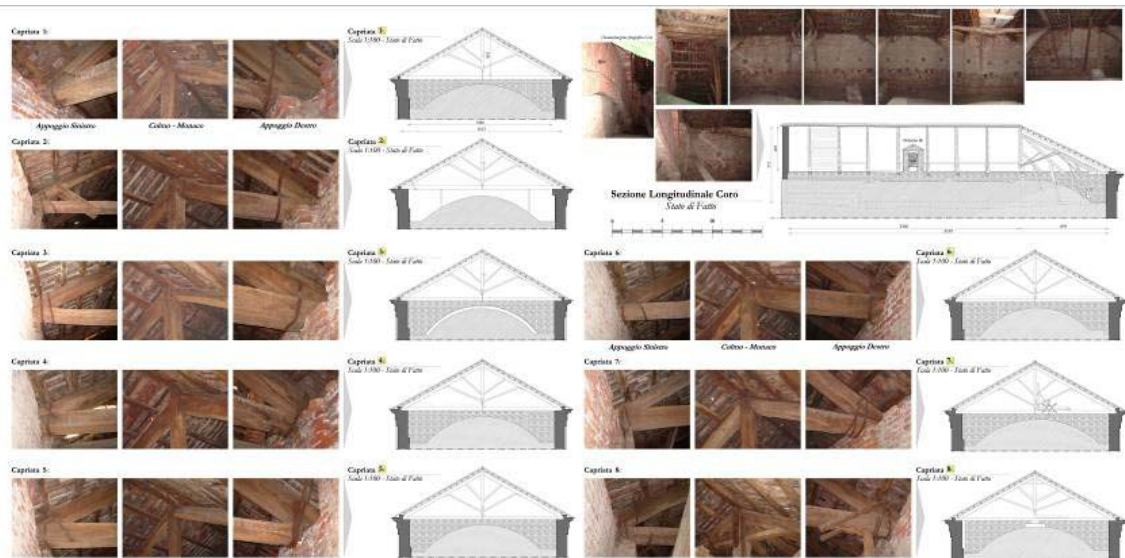
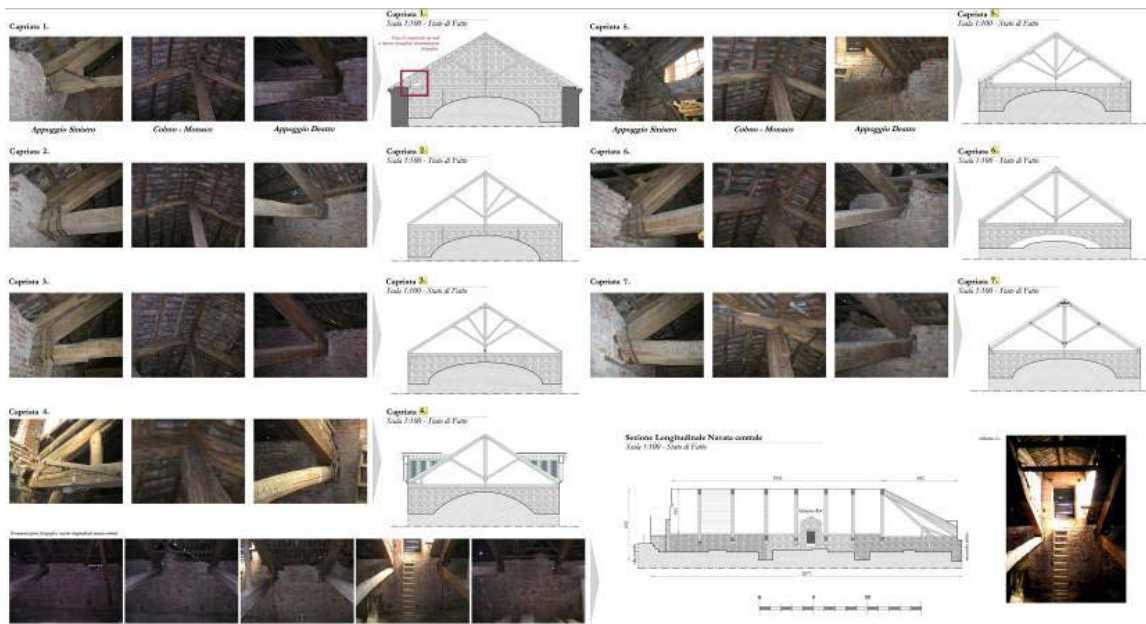
Figure 6 – Survey of the trusses of the transept-choir and of the central nave

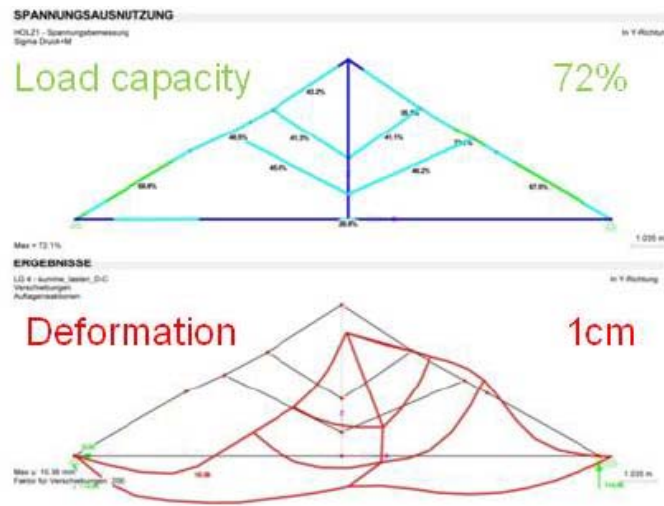
Figure 7– Results for the load case D-C (highest loads)

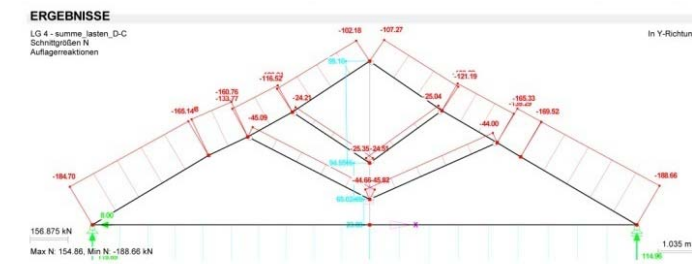
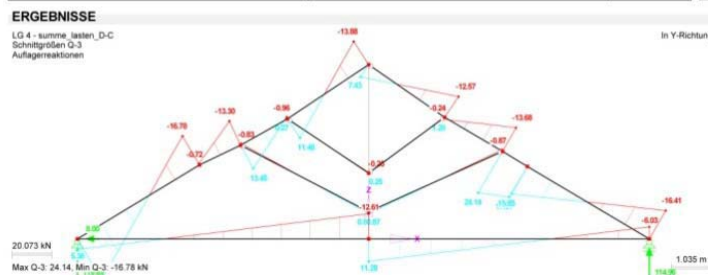
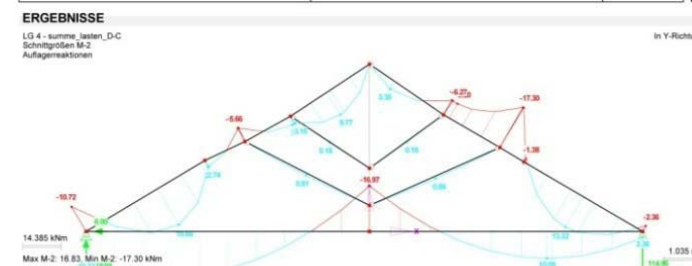
Figure 8 – Axial force working on the beams (a); shear force working on the beams (b); axial force working on the beams (c).
